4. TITLE (and Subtitle) <b>National Program of Inspection of Non-Federal Dams, Tennessee. Cumberland Springs Lake Dam (Inventory Number TN 12701) near Lynchburg, TN., Moore County, TN., Elk River Basin</b>		5. TYPE OF REPORT & PERIOD COVERED <b>Phase 1 Investigation Report</b>

14. MONITORING AGENCY NAME & ADDRESS (if different from Controlling Office) <b>Tennessee Department of Conservation Division of Water Resources 4721 Trousdale Drive Nashville, TN 37220</b>		12. REPORT DATE <b>September, 1981</b>

PHASE I INSPECTION  
CUMBERLAND SPRINGS DAM  
MOORE COUNTY, TENNESSEE

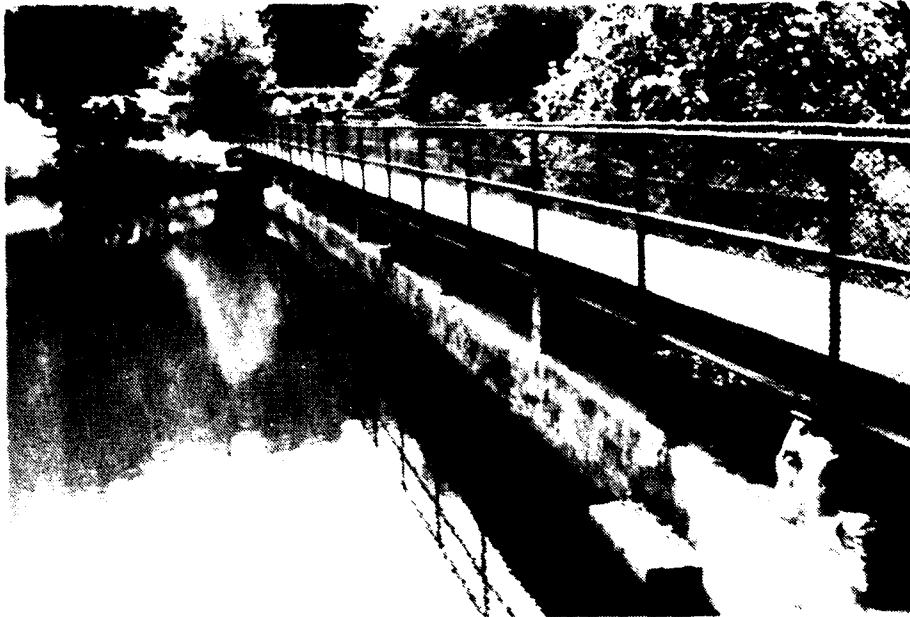
1. Top of dam and upstream face. From west abutment.

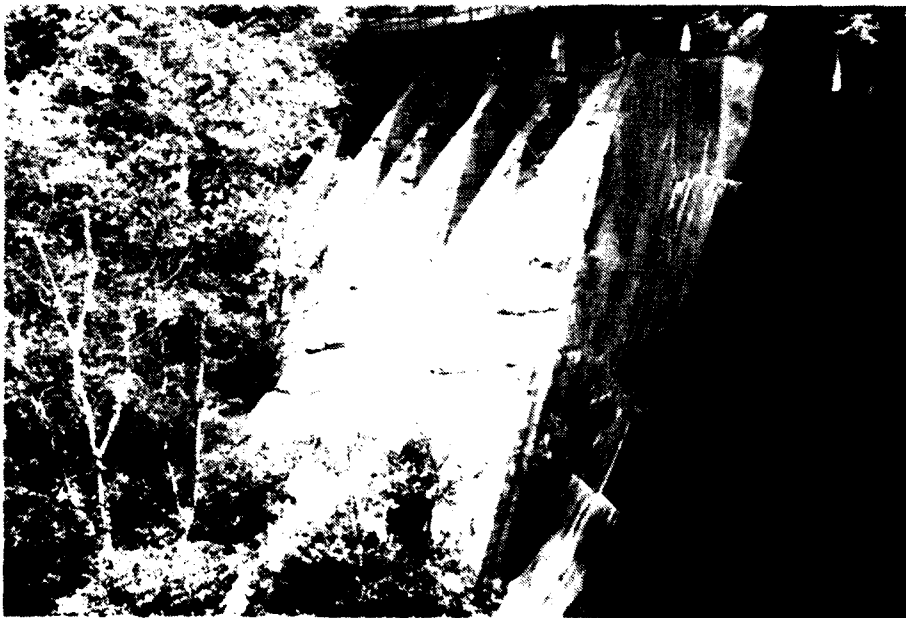
End Walls - The end walls of the dam are keyed into rock and supported by buttresses at varying intervals. The buttresses are badly weathered. The weathering is less in the buttresses nearest the west abutment. Weathering extends well back in the construction joints, about 10 feet above the base of the dam. These joints are open some 10 to 15 feet in length and 6 inches into the concrete. The buttresses are undermined. Iron stained water was noted between the first and second buttresses west of the spillway, and also between the second and third. The upstream faces have been gunited and are in good shape. The concrete in the dam used crushed limestone aggregate. According to Mr. Motlow, a 2:2:2 (cement-fine aggregate-course aggregate) mix was used. The water--cement ratio is not known. Judging from chunks of concrete washed downstream from the first dam, the maximum size of aggregate is about 6 inches. The aggregate includes significant quantities of chert.

2. Downstream face of Cumberland Springs Dam. Note erosion of buttresses.

The downstream side of the dam has cracks as much as 6 inches deep. A horizontal surface crack extending practically the length of the dam is believed to be a cold joint. This crack or cold joint is approximately 10 feet above the foundation sill, and has opened as much as 6 to 8 inches in depth.

RECOMMENDATIONS. It is recommended that the leak in the east end wall be stopped. The undermined foundations of the buttresses should be repaired and protection should be provided to prevent future undermining of the buttresses. Open construction joints and the weather surface of the abutments should be

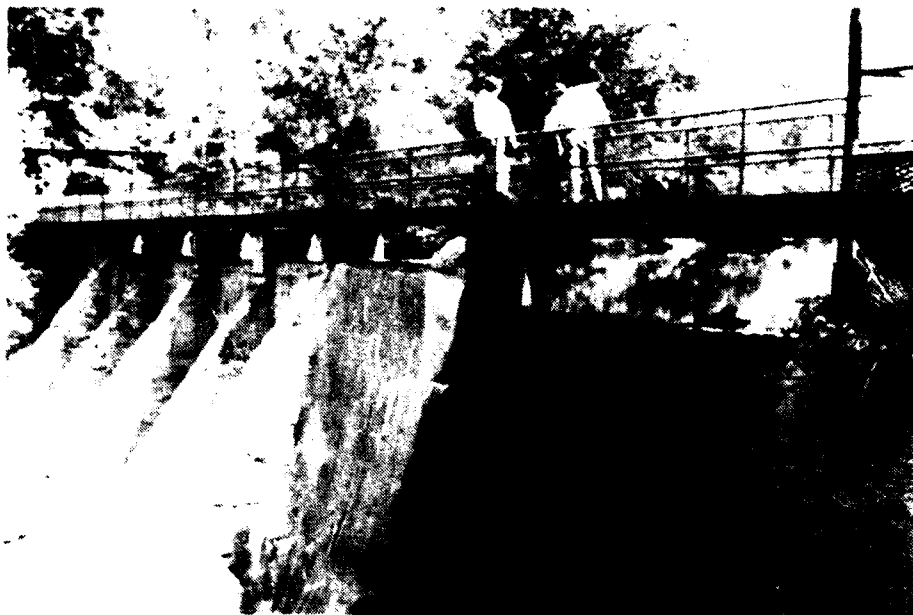
3. Emergency spillway section at top of Cumberland Springs Dam. Note drawdown gate hoist on upstream face of dam and at center of spillway.
